Understanding Saba's (ground)water system and nutrient pathways

An integrated hydrogeological and nutrient flux study of Saba, Caribbean Netherlands

Version	1.0
Date	10-07-2025
Project nr.	11210862-002
Document ID	11210862-002-BGS-0001
Pages	89
Classification	
Status	Final

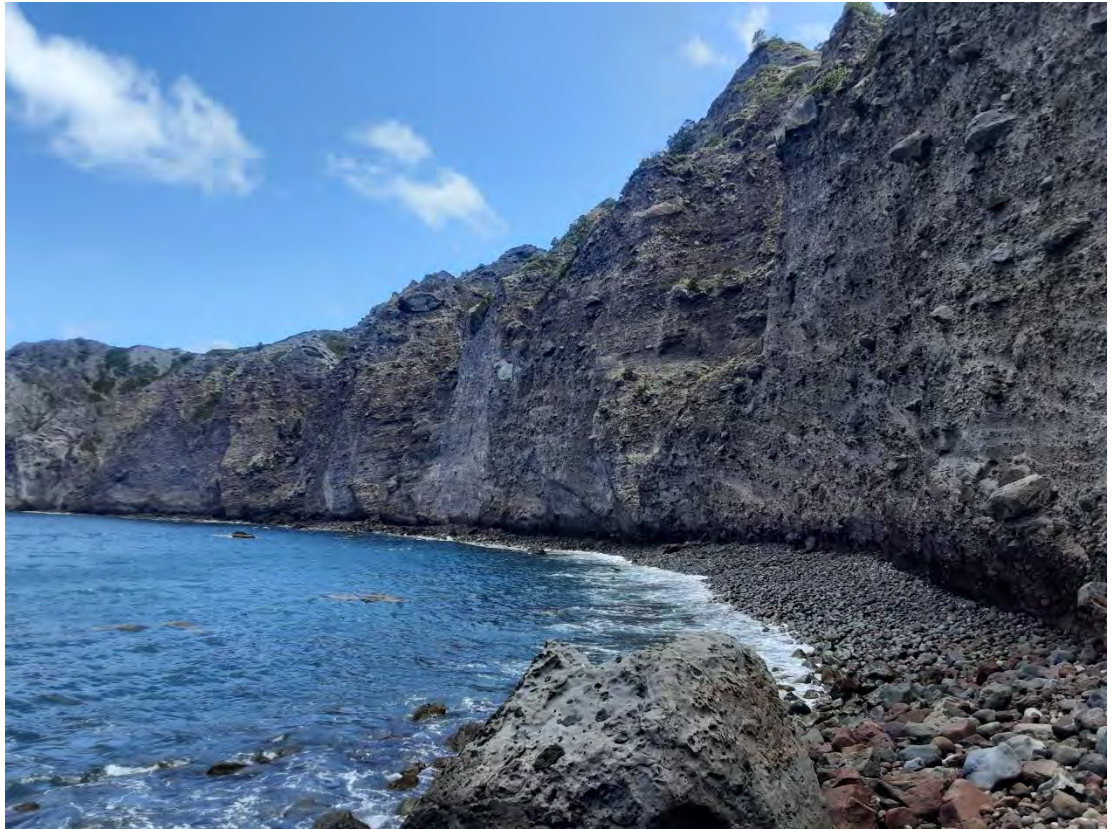
Figure 2.5 Agglomerates deposits as cliffs at Well's Bay (Photograph by author).

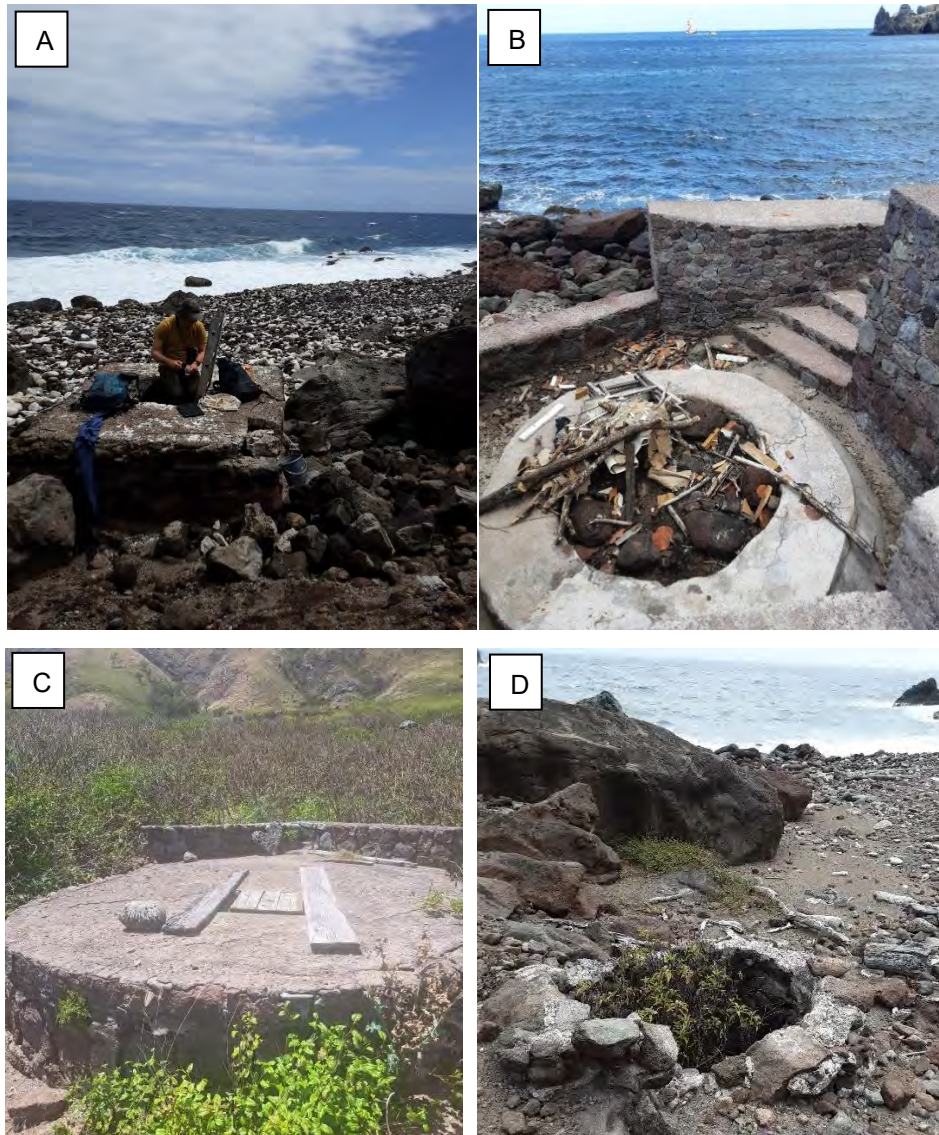
Figure 2.9 Photos of groundwater wells at the coast of Saba, A) Hole in the corner, B) Well's Bay, C) Spring Bay, D) Core Gut Bay (Photographs by author).

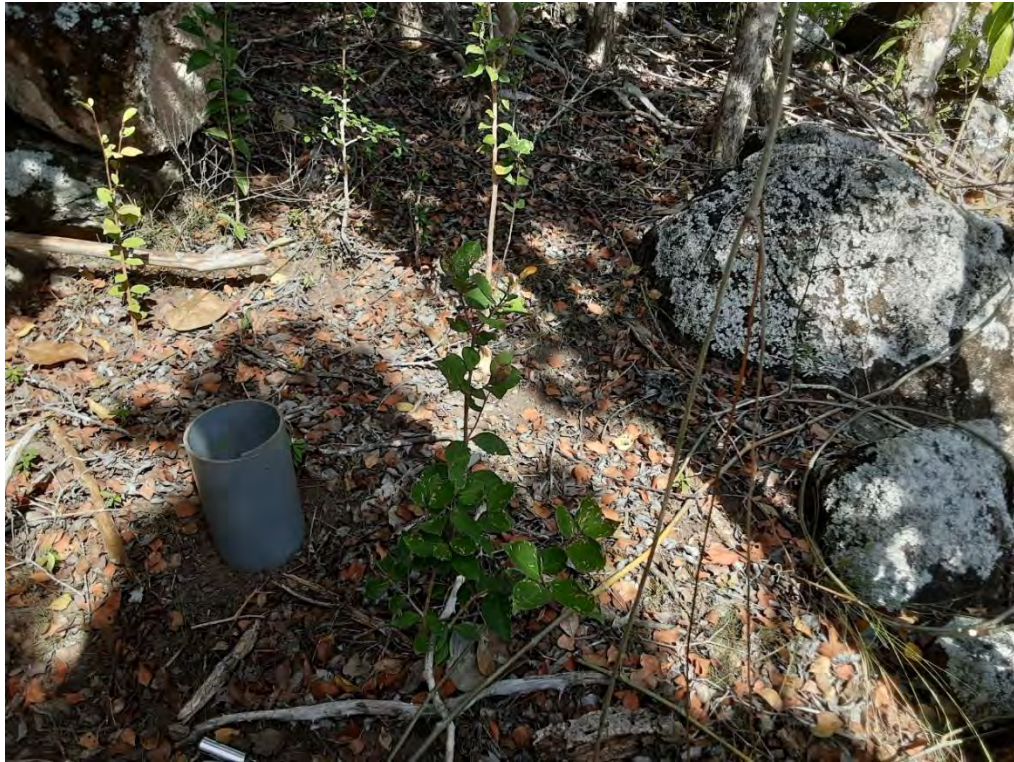
Figure 3.1 PVC infiltration ring used in the field (Photograph by author).

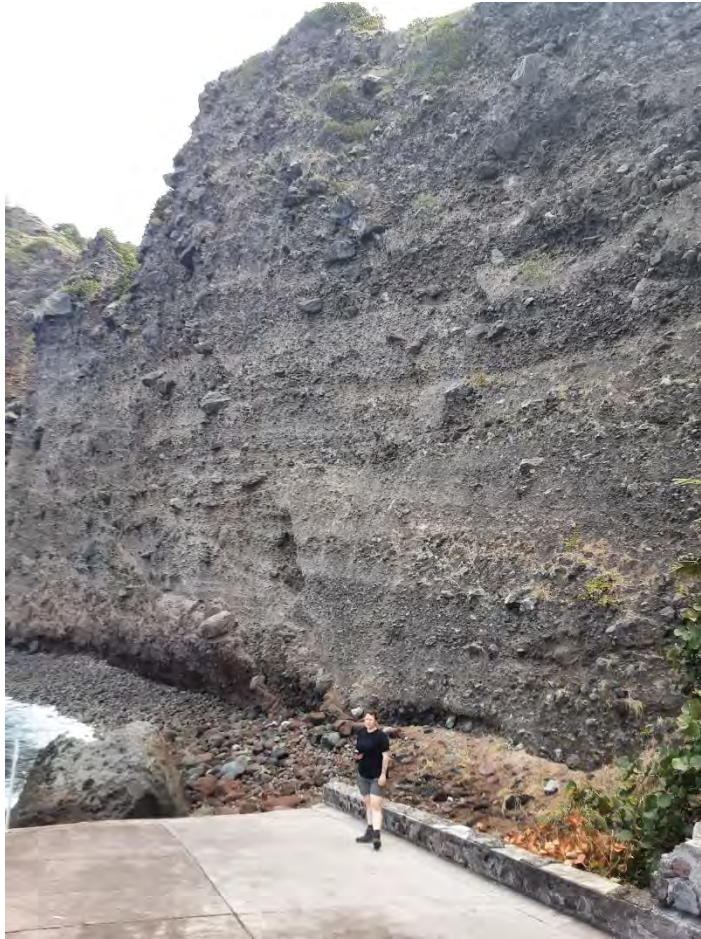
Figure 4.3 Outcrop at Well's Bay (Geo_11 in Figure 4.2). Human (1.70cm) for scale. Layered agglomerates consisting of fine and big boulders and volcanic bombs in a loose sandy matrix of tuff and ashes (Photograph by author).

At several locations thick layers of agglomerates could be observed. The occurrence of this geological formation is widespread and important for groundwater flow and nutrient transport due to the high permeability. An agglomerate is the mixture of volcanic deposits containing small to big blocks, volcanic bombs embedded in a matrix of fine ash, sand or tuff. Figure 4.3 and Figure 4.4 illustrate outcrops at locations Geo_11 and Geo_8, respectively, showcasing the agglomerate deposits. These agglomerates are widespread surrounding the different domes observed throughout Saba, with its thickness increasing at lower elevations, particularly toward the coastline.

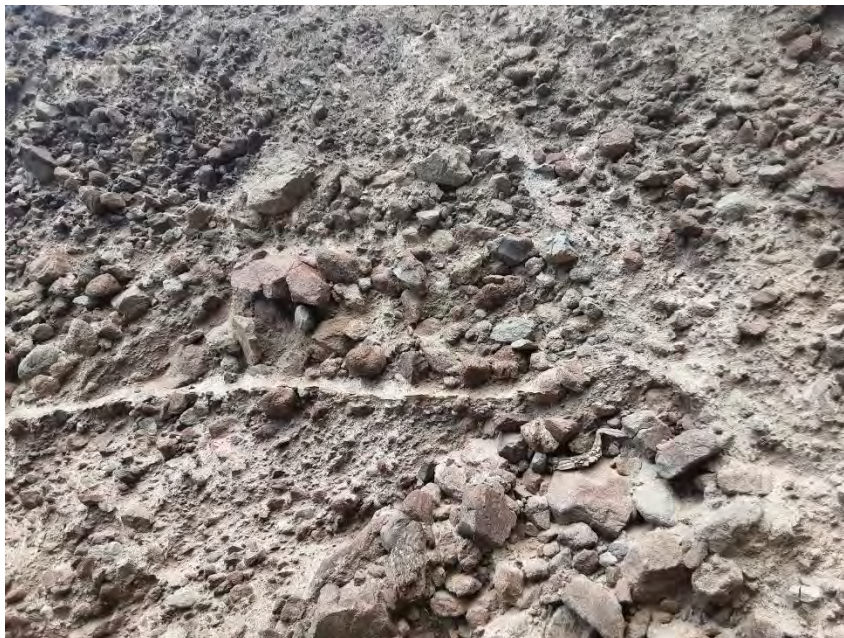
Figure 4.4 Outcrop at Geo_8, on the road to Well's Bay. Agglomerates with ranging boulder sizes (Photograph by author).

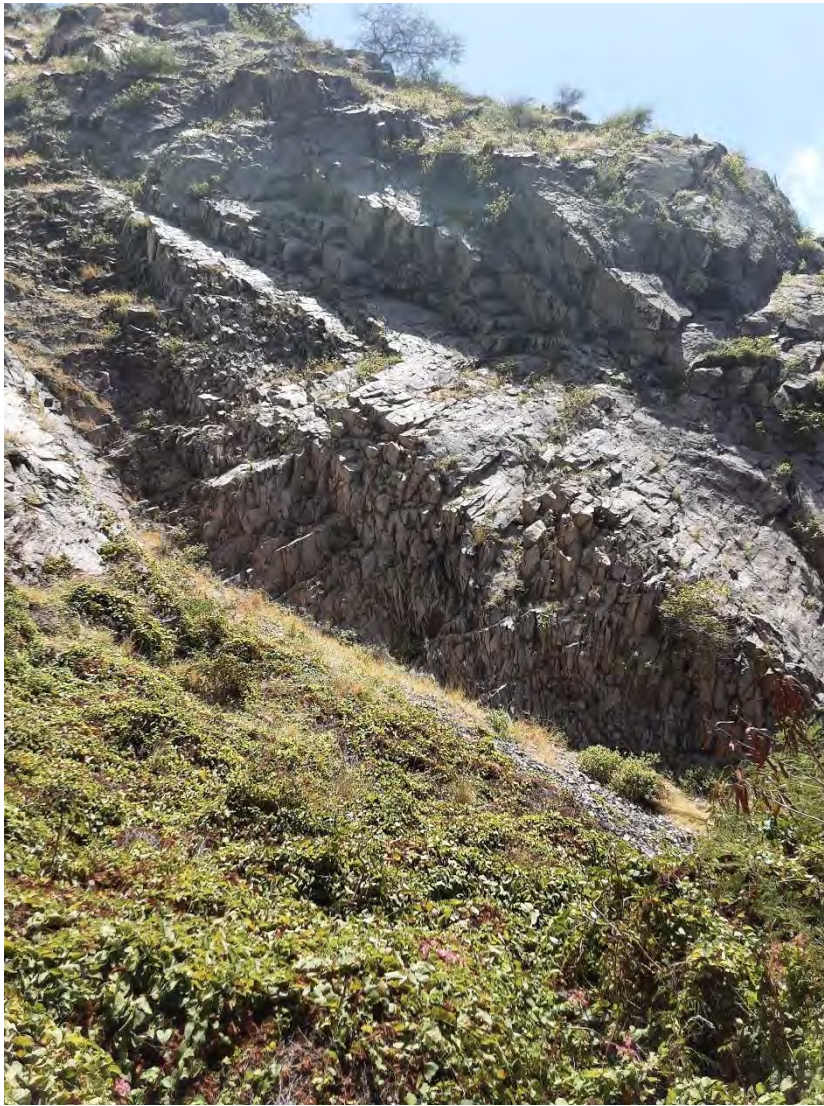
Figure 4.5 Outcrop at Geo_12, on road towards harbour. Andesite rock of one the domes exposed at the surface (Photograph by author).

Below the agglomerates, the andesite bedrock, often called “blue/black rock” by locals, is found (Figure 4.5). This hard volcanic rock is part of a layered subsurface, built up from different volcanic eruptions over time. The result is a sequence of layers with varying permeability. The andesite itself is mostly impermeable, but where fractures occur, some groundwater flow is still possible. In contrast, the overlying agglomerates and pyroclastic deposits are much more permeable and allow easier infiltration. This interbedded system of more and less permeable layers controls how groundwater moves through the subsurface. The groundwater flow is therefore strongly influenced by the location and connectivity of these layers.

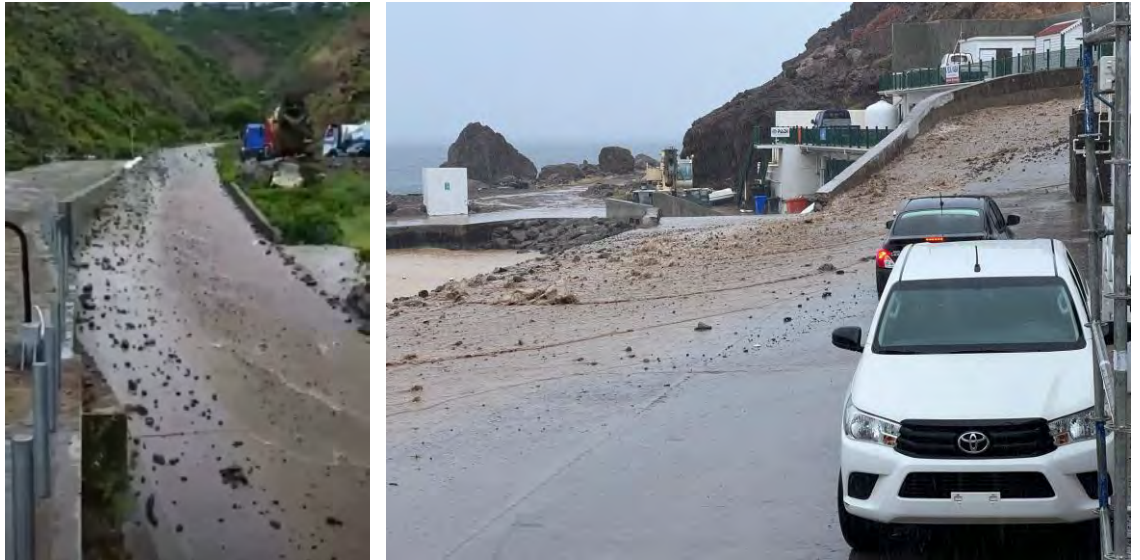
Figure 4.7 Rainwater runoff on the road towards the harbour (Dinten Fernandez, 2025).

Runoff and flooding were also frequently discussed. Many residents noted that water regularly flows along roads during rainfall events. Approximately three to five times a year, rainfall is heavy enough to cause significant flooding and landslides (sediments and rocks on the road), rendering the road to the harbour impassable during those times (Figure 4.7). During periods of intense rainfall, visible sediment plumes are observed in Fort Bay and Spring Bay, indicating surface runoff and erosion into the marine environment.

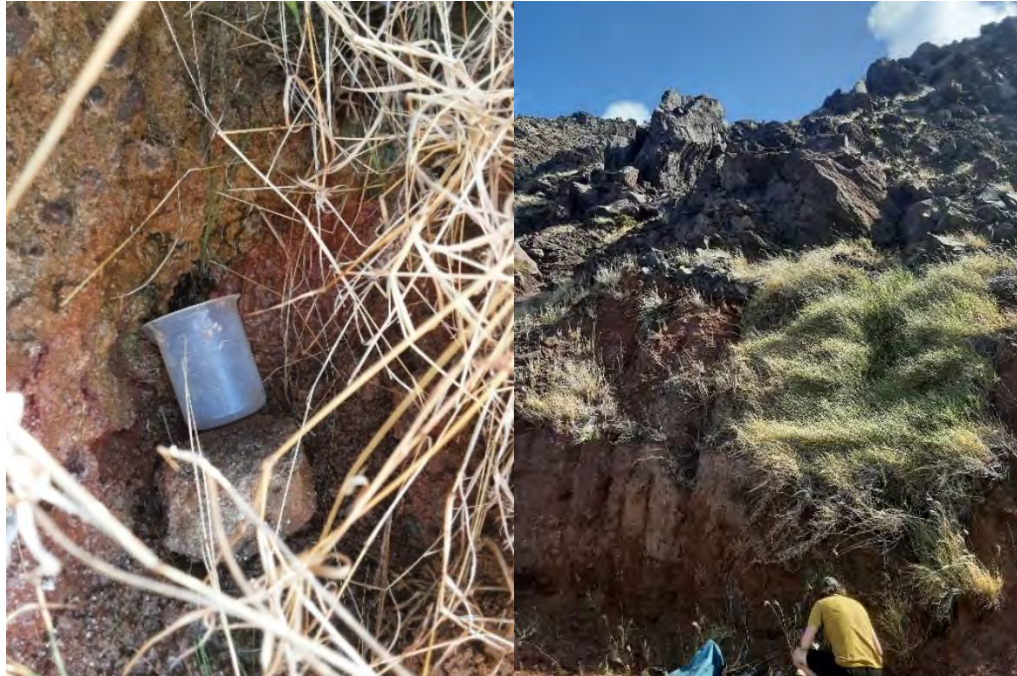
Figure 4.9 Groundwater spring at Tent Bay (SABA004). Situation overview on the right and seeping groundwater and collection cup on the left (Photographs by author).

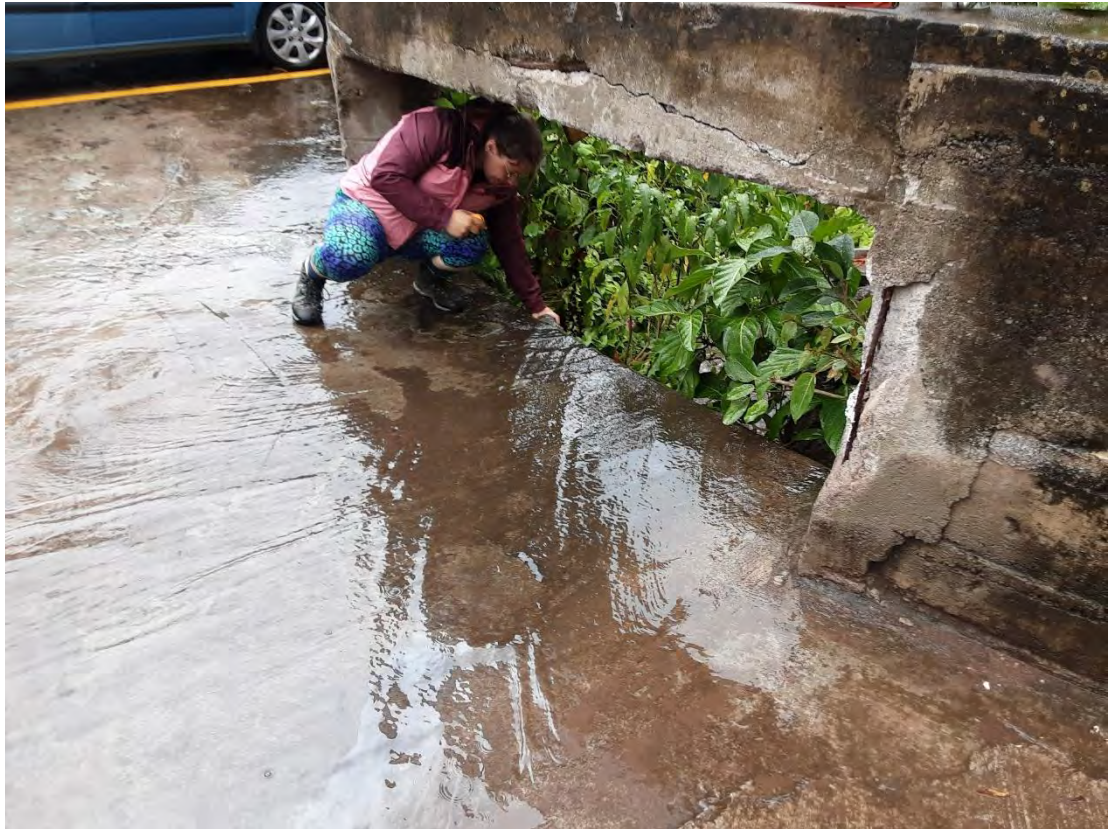
Figure 4.10 Collecting street runoff in The Bottom during rainfall (SABA002) (Photograph by author).

The street runoff was collected on the road during rainfall, such as depicted in Figure 4.10. SABA001, SABA002, and SABA003 were collected in this manner. This runoff was collected from the built environment and has not percolated through the subsurface.

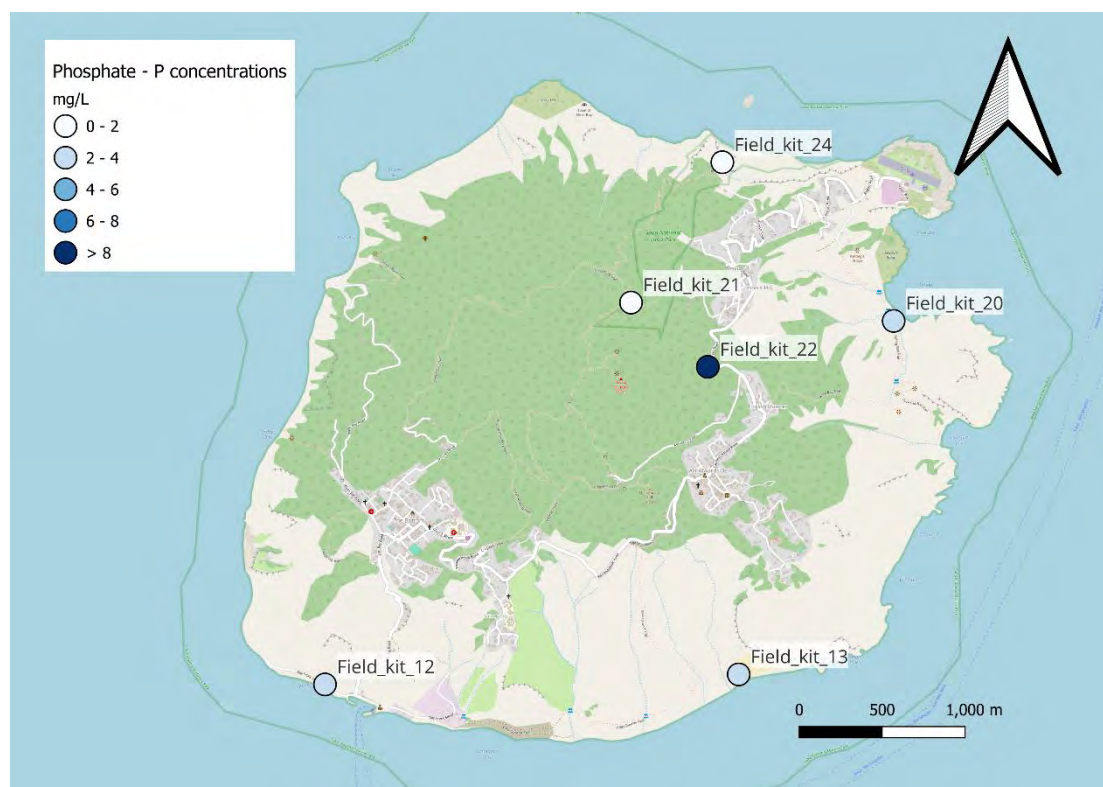
Figure 4.16 Phosphate - P (mg/L) concentration measured with quick scan field kits.

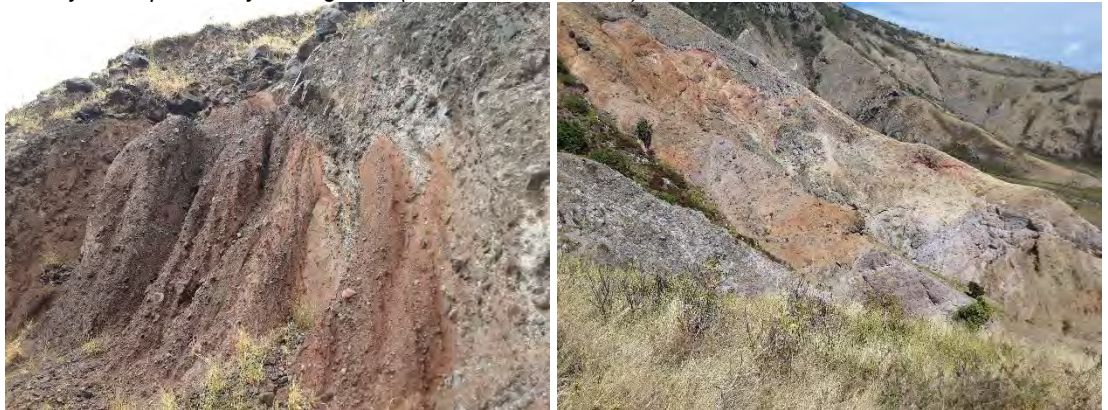
Erosion on exposed steep slopes and gullies without any vegetation

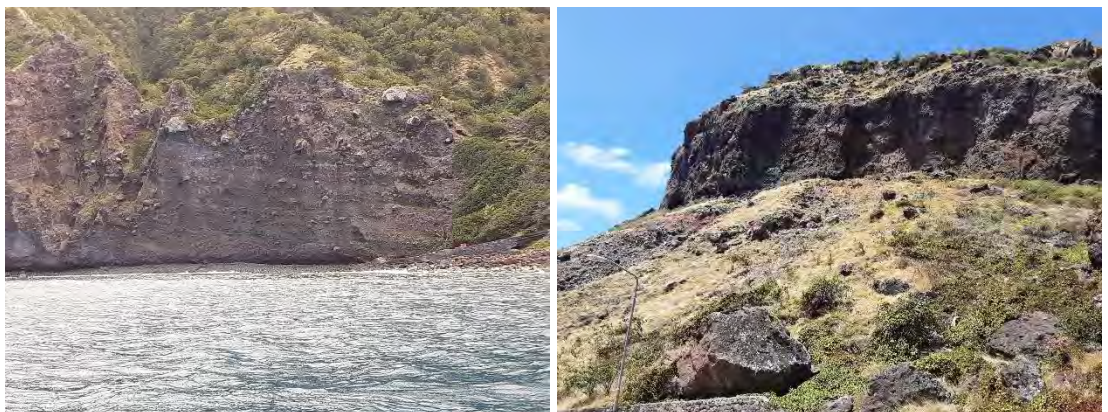
Pyroclastic flow sediments with volcanic bombs at Wells Bay (left) and outcrop of andesitic hard rock (right)

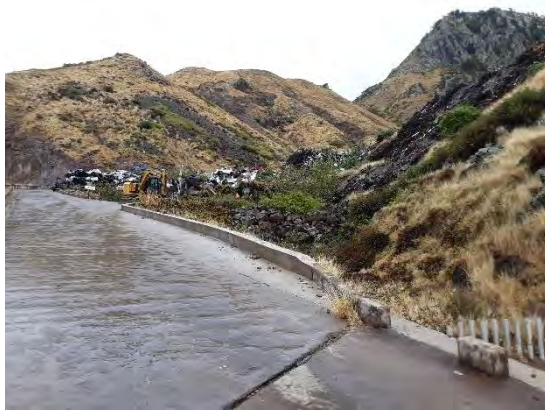
Street runoff after a moderate rainfall event

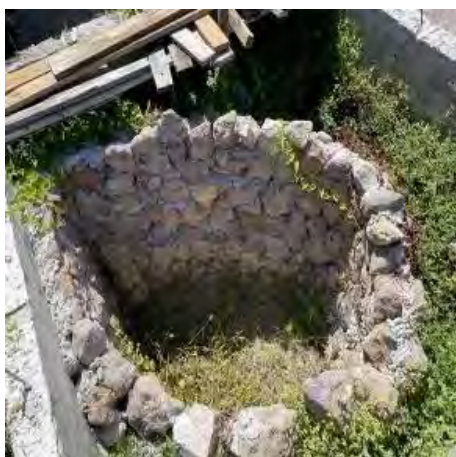
Figure 6.4 Cesspit in construction (VEI, 2023)
